NBSIR 86-3492

Evaluation of Cracking in Aluminum Cylinders

Final Report

This work was sponsored by
Department of Transportation
Washington, DC 20590

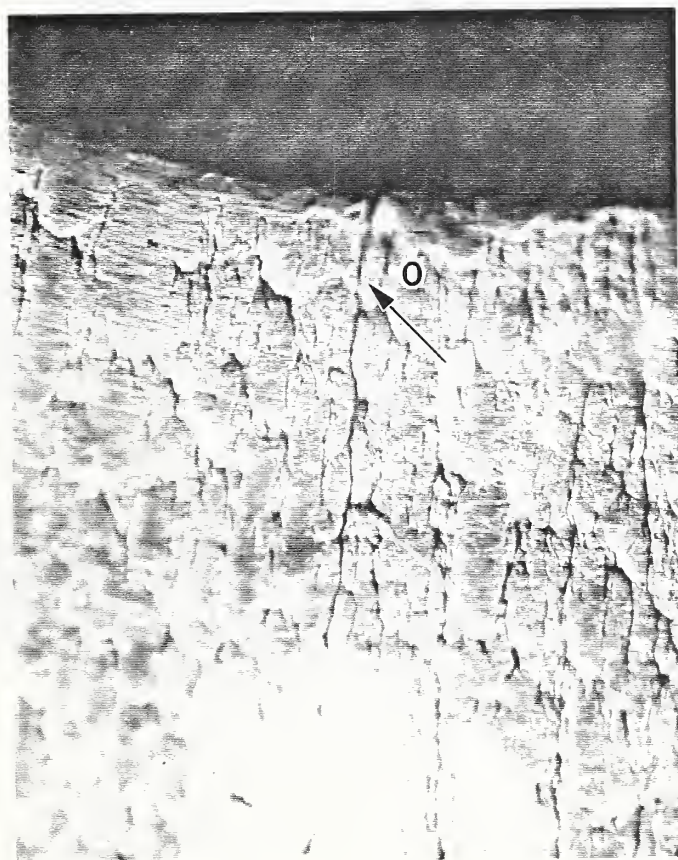
Fig. 7

neck area of the cylinder showed crack-like indications in the neck area of the cylinder and the cylinder was removed from service for further examination. The detailed visual examination conducted as part of this investigation showed crack-like indications at positions "0", "3", and "6". All the crack-like indications appeared to be approximately 1/4-inch long on the inside surface of the neck just below the straight drilled portion of the neck. Visual examination showed that none of the crack-like indications extended into the threads of the cylinder. An example of the most distinct crack-like indication found by visual examination at position "0" is shown in Figure 7.

Crack-Like Indication

Cyl. No. U-53388 Mag. 10x

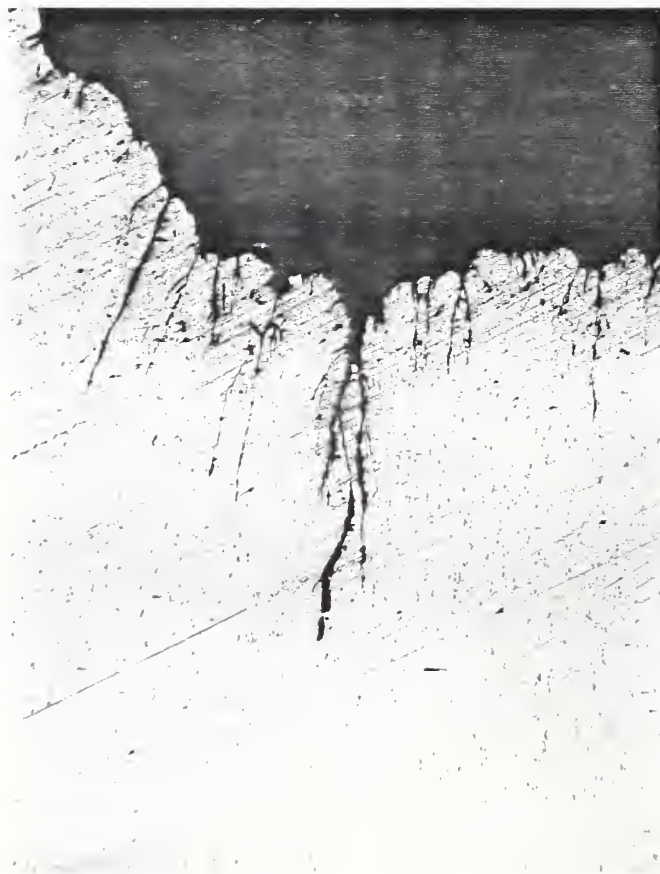
Fig. 8

Metallographic examination of the crack-like indication at position "0" was conducted with successive sections taken starting from the lower part of the inside of the neck of the cylinder. As shown in Figure 8, the crack-like indications were identified by metallographic examination to be distinct cracks. Multiple cracks and branching cracks were found that originated at the root of the metal folds in the cylinder neck. The maximum depth of the crack measured on the metallographic specimen (d) was approximately 0.043-inch and the metallographic examination showed that the crack was approximately 1/4-inch long and did not extend into the smooth drilled area outside of the neck area of the cylinder. This examination did confirm that the crack-like indications that were observed by visual examination in the neck of the cylinder were definitely cracks and that multiple cracks existed that could not be distinguished by visual observation from the folds in the neck of the cylinder. The thickness of the cylinder neck is approximately 1-1/16 inch, so as shown in Figure 9, the total depth of cracking is limited to less than 5% of the wall thickness of the neck after 12 years of service. This amount of crack growth is not considered to be critical or to degrade the structural integrity of the cylinder at this time. Due to the limited extent of cracking at position "0", the other cracks at positions "3" and "6" were not examined metallographically at this time.

Primary Crack in Cylinder Neck

Cyl. No. U-53388 Mag. 40x

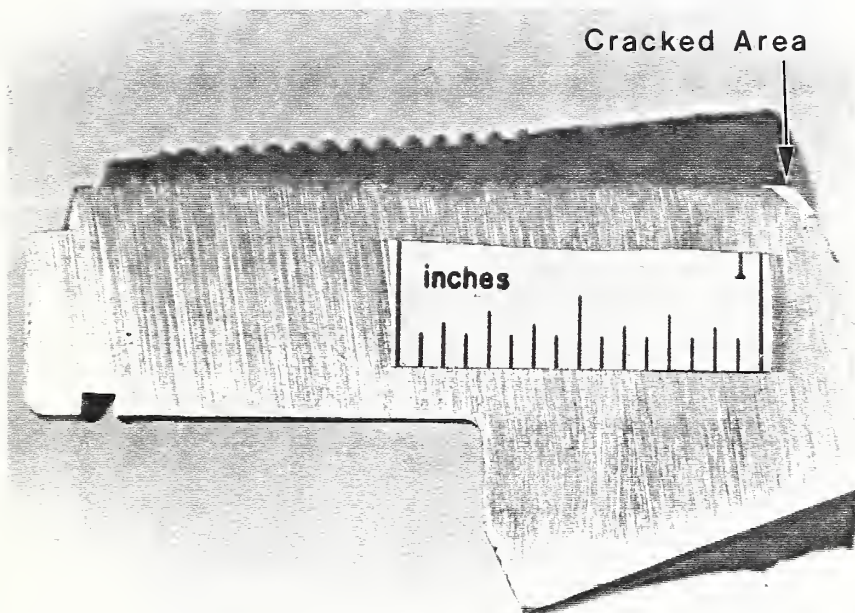
Fig. 9

Extent of Primary Crack

Cyl. No. U-53388

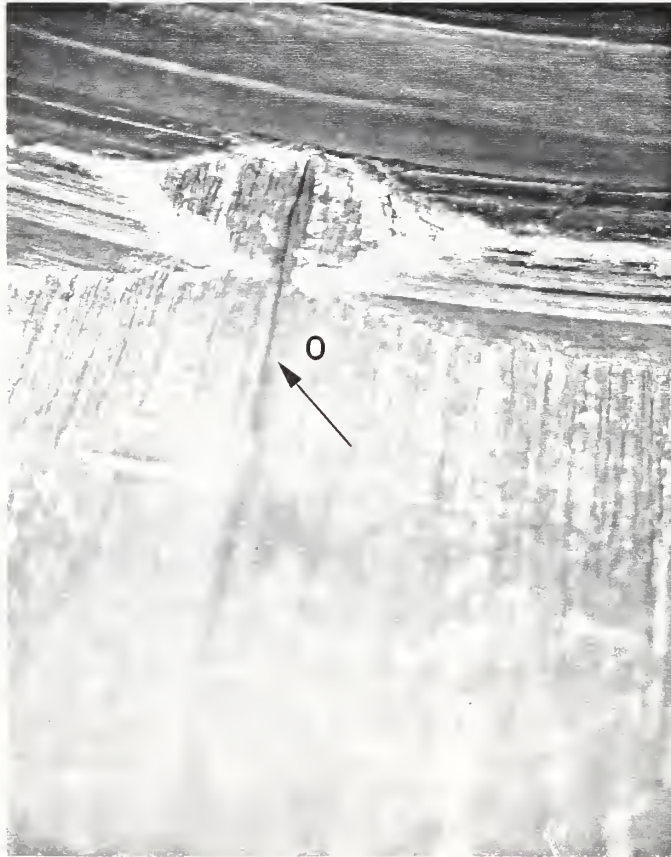
Fig. 10

This cylinder was manufactured to DOT specification 3A1 and the date of the first hydrostatic test was May 1985. The neck and threaded area of the cylinder were examined visually in early 1986 and the cylinder was removed from service at that time due to the appearance of crack-like indications in the neck. The detailed visual examination conducted as part of this investigation showed the presence of crack-like indications at positions "0", "1", "3", "5", "6", "7", "8", "10" and "11". All of the crack-like indications appeared to be approximately 1/4-inch long and none extended into the straight drilled portion of the cylinder head above the neck. An example of the most distinct crack-like indication found by visual examination at position "0" is shown in Figure 10.

Crack-Like Indication

Cyl. No. U-419288 Mag. 6x

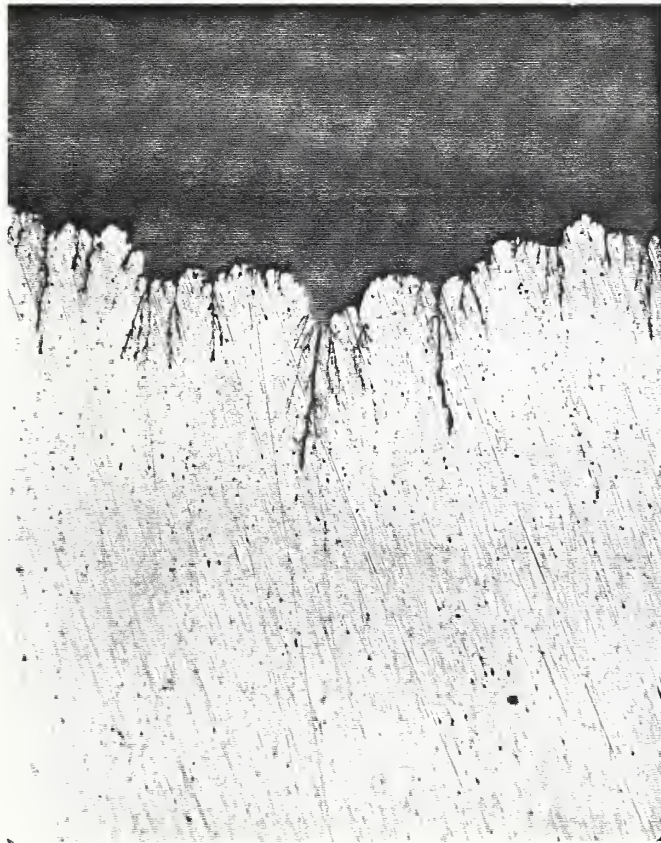
Fig. 11

Metallographic examination of the crack-like indication at position "0" was conducted with successive sections taken starting from the lower part of the inside of the neck of the cylinder. As shown in Figure 11, the crack-like indications were found by metallographic examination to be distinct cracks. Multiple cracks and branching cracks were found that originated at the root of the metal folds in the cylinder neck. The maximum depth of the crack measured on the metallographic specimen was approximately 0.022 inch and the metallographic examination showed that the crack was approximately 1/2-inch long but did not extend into the smooth drilled area outside of the neck area of the cylinder. This examination did confirm the crack-like indications that were observed by visual examination in the neck of the cylinder were definitely cracks and that multiple cracks existed that could not be distinguished by visual observation from the folds in the neck of the cylinder. The thickness of the cylinder neck is approximately 1-inch, so as shown in Figure 12, the total depth of cracking is limited to less than 5% of the wall thickness of the neck. This amount of crack growth is not considered to be critical or to degrade the structural integrity of the cylinder at this time. Due to the limited extent of cracking at position "0", the other cracks at positions "1" through "11" were not examined metallographically.

Primary Crack in Cylinder Neck
Cyl. No. U-419288 Mag. 40x

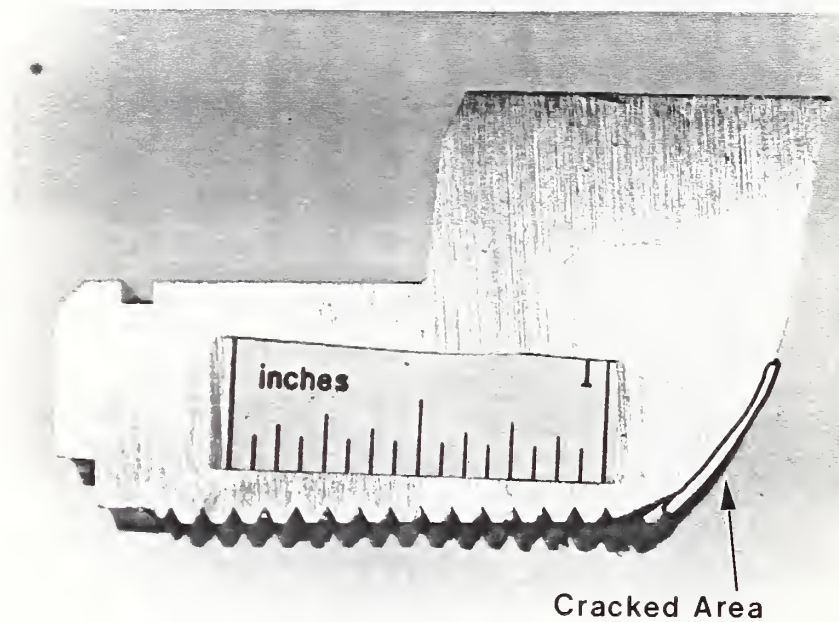
Fig. 12

Extent of Primary Crack

Cyl. No. U-419288

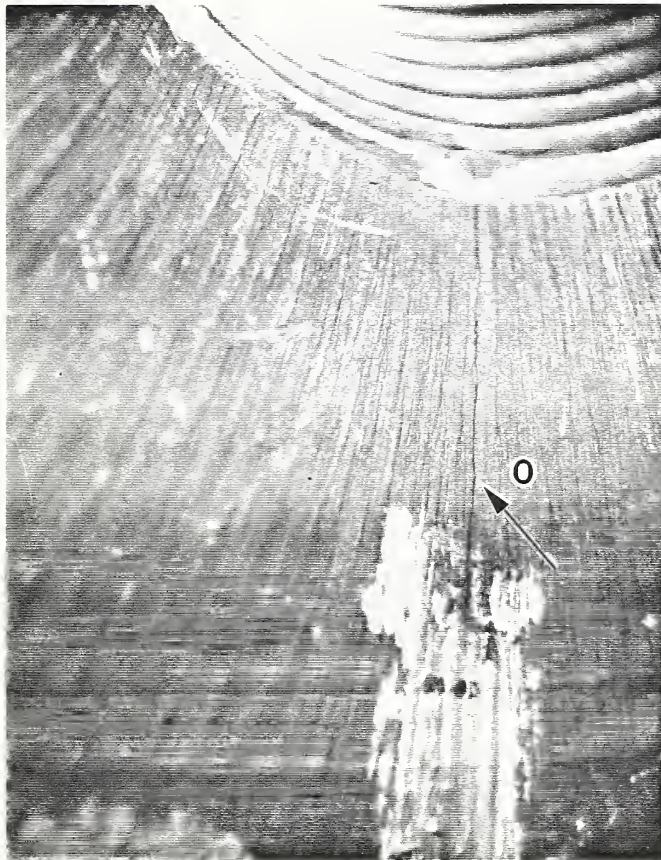
Fig. 13

The detailed visual examination conducted as part of this investigation showed crack-like indications at positions "0", "2", "3", "6", and "9". All of the crack-like indications appeared to be approximately 1/4 to 1/2-inch long and none extended into the threaded portion of the cylinder head above the neck. An example of the most distinct crack found by visual examination at position "0" is shown in Figure 13.

Crack-Like Indication

Cyl. No. T-266763 Mag. 10x

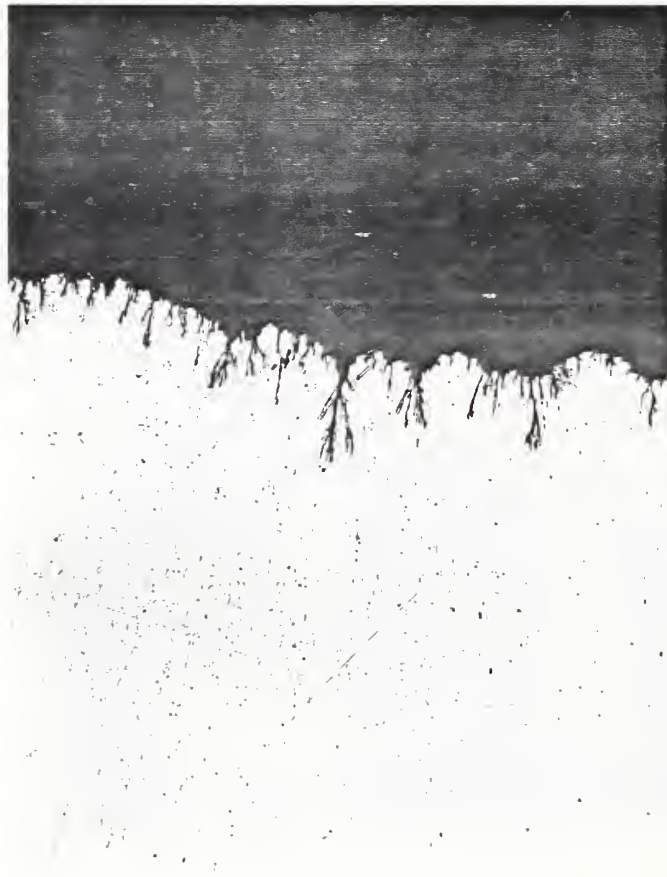
Fig. 14

Metallographic examination of the crack-like indication at position "0" was conducted with successive sections taken starting from the lower part of the inside of the neck of the cylinder. As shown in Figure 14, the crack-like indication was found by metallographic examination to be a distinct crack. Multiple cracks and branching cracks were found that originated at the root of the metal folds in the cylinder neck. The maximum depth of the crack measured on the metallographic specimen (d) was approximately 0.023-inch and the metallographic examination showed that the crack was approximately 1/2-inch long but did not extend into the threaded area outside of the neck area of the cylinder. This examination confirmed that crack-like indications that were observed by visual examination in the neck of the cylinder were definitely cracks and that multiple cracks existed that could not be distinguished by visual observation from the folds in the neck of the cylinder. The maximum thickness of the cylinder neck is approximately 1-inch, so as shown in Figure 15, the total depth of cracking is limited to less than 5% of the wall thickness of the neck. This amount of crack growth is not considered to be critical or to degrade the structural integrity of the cylinder unless further crack growth occurs. Due to the limited extent of cracking at position "0", the other cracks at positions "2" through "9" were not examined metallographically at this time. Only metallographic examination was done on this cylinder (no three-point bend specimens were tested).

Primary Crack in Cylinder Neck

Cyl. No. T-266763 Mag. 40x

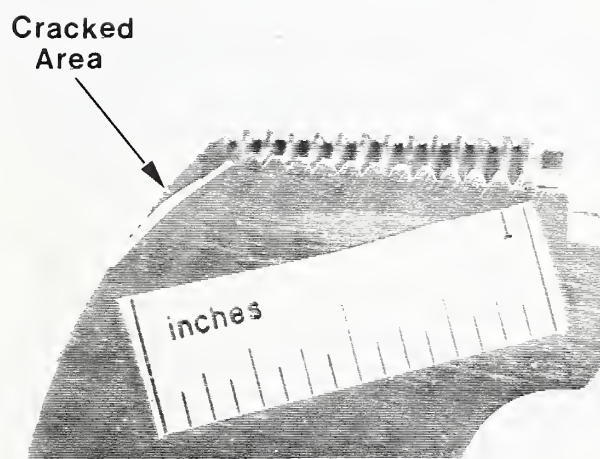
Fig. 15

Extent of Primary Crack

Cyl. No. T-266763

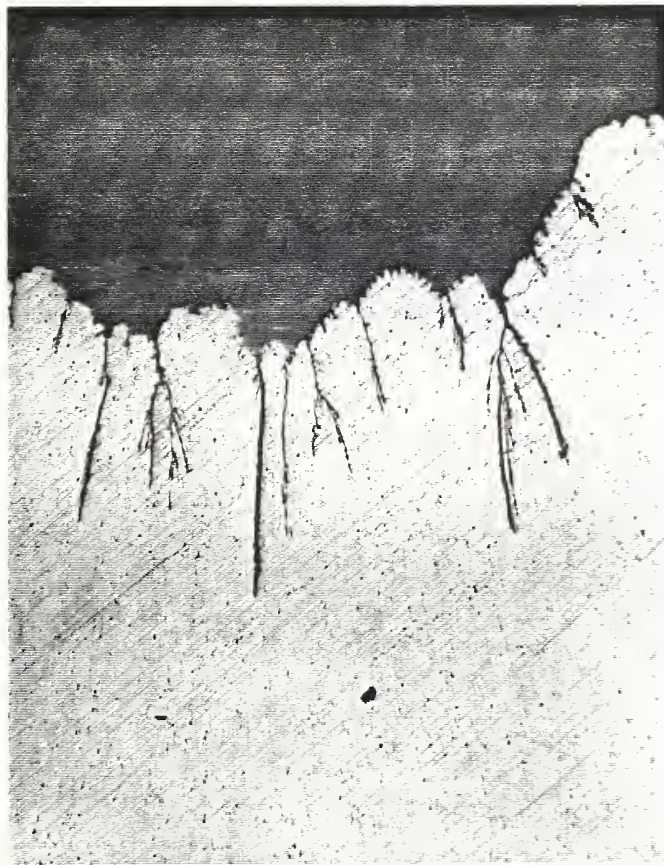
Fig. 17

Metallographic examination of the crack-like indication at position "6" was conducted with successive sections taken starting from the lower part of the inside of the neck of the cylinder. As shown in Figure 17, the crack-like indications were found by metallographic examination to be distinct cracks. Multiple cracks and branching cracks were found that originated at the root of the metal folds in the cylinder neck. The maximum depth of the crack at position "6" that was measured on the surface of the metallographic specimen (d) was approximately 0.039-inch and the metallographic examination showed that the crack was approximately 3/8-inch long but did not extend into the threaded area outside of the neck area of the cylinder. This examination did confirm that the crack-like indications were definitely cracks and that multiple cracks existed that could not be distinguished by visual observation from the folds in the neck of the cylinder. The maximum thickness of the cylinder neck is approximately 1-1/8-inch, so as shown in Figure 18, the total depth of cracking is limited to less than 5% of the wall thickness of the neck. This amount of crack growth is not considered to be critical or to degrade the structural integrity of the cylinder at this time. Due to the limited extent of cracking at position "6", the other cracks at positions "2" through "10" were not examined metallographically at this time.

Primary Crack in Cylinder Neck
Cyl. No. T-262190 Mag. 40x

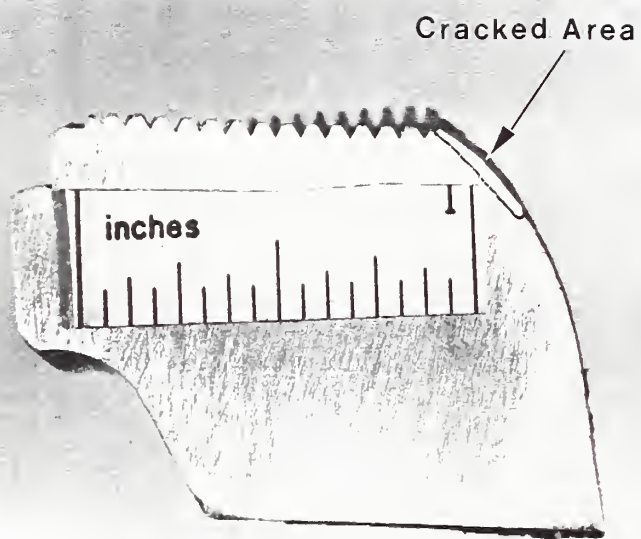
Fig. 18

Extent of Primary Crack

Cyl. No. T-262190

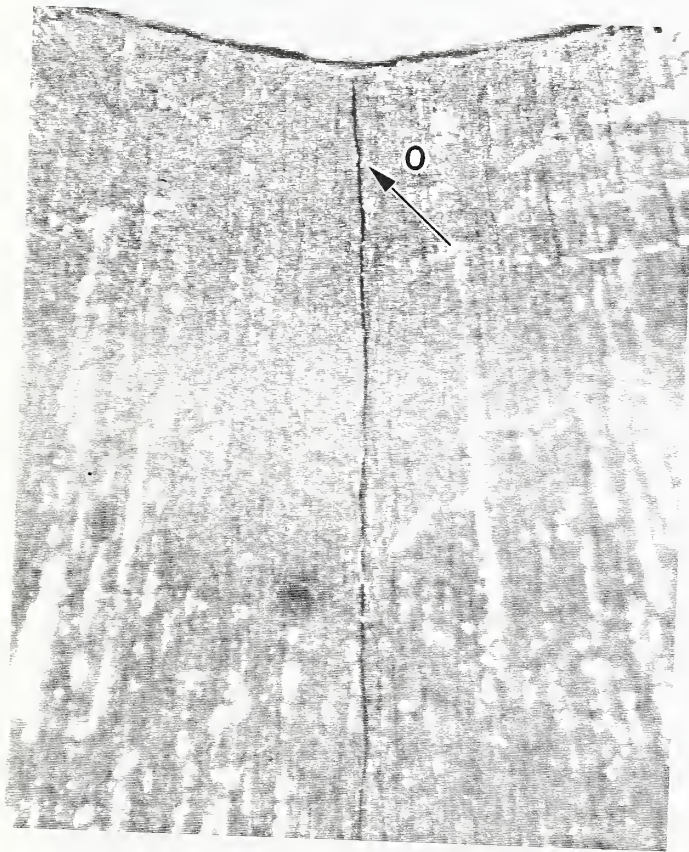
Fig. 19

Visual examination showed the presence of crack-like indications at positions "0", "3" and "8". The crack-like indication at position "0" was about 1-inch long. The crack-like indications at positions "3" and "8" were approximately 1/2-inch long. None of the crack-like indications extended into the threaded portion of the cylinder head above the neck. An example of the most distinct crack-like indication found by visual examination at position "0" is shown in Figure 19.

Crack-Like Indication

Cyl. No. T-256255 Mag. 12x

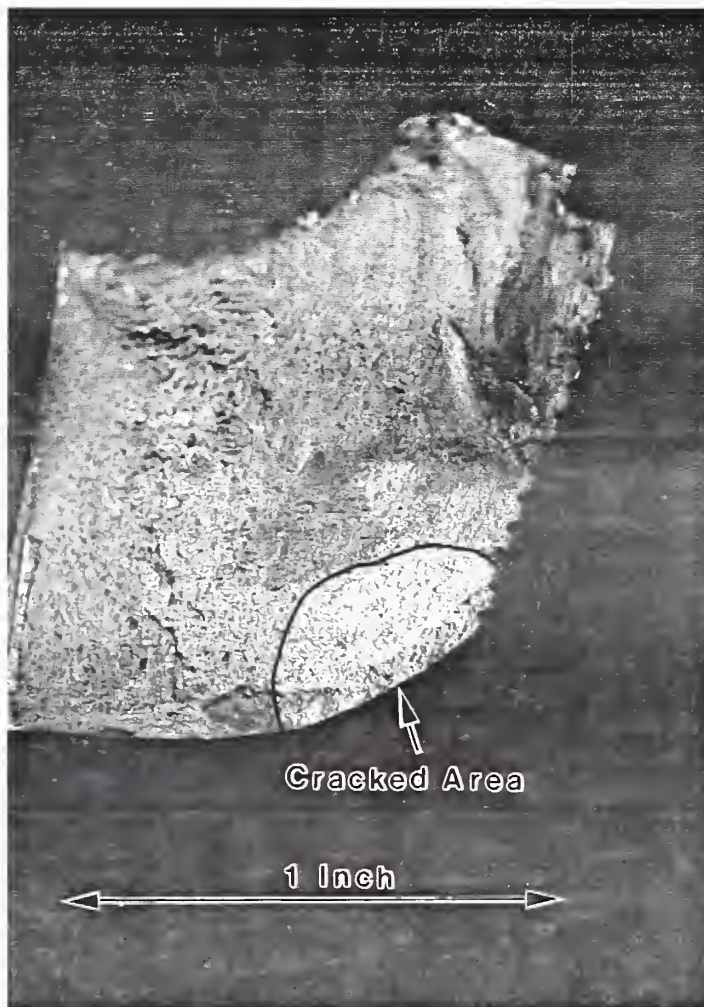
Fig. 20

A three point bend specimen was made at position "0" and broken open to delineate the crack. This crack was very distinct as shown in Figure 20. The crack was about 0.30-inch deep and 5/8-inch long. The maximum thickness of the cylinder neck is approximately 1-inch, so the crack is nearly 1/3 of the way through the neck of the cylinder. This crack clearly shows the extent of cracking that can occur in these DOT-3Al type cylinders and shows that even a crack of this depth does not extend into the threaded area of the neck and would not be detected just by looking only at the threaded area of the cylinder. This was the largest crack that was detected in the eight cylinders that were examined in this investigation. An analysis of the structural significance of this crack was not made but it is reasonable to expect that a crack of this depth would grow to the extent that leakage of the cylinder would occur before the next required hydrostatic test. No metallographic examination was done of the crack at position "0". The scanning electron microscope examination that was done of the fracture surface and did indicate that the crack growth was by the slow crack growth mode previously found in the high pressure aluminum cylinders (Ref.2).

The results of these tests show conclusively that substantial cracking can occur in DOT-3Al cylinders at a service pressure of 2216 psi after only five years of service. This is particularly well shown by the substantial crack found in cylinder No. T-256255. Other cracks in the same cylinder and in the other two cylinders examined were less than 0.050-inch and are not believed to be structurally significant at this time but may be initiation sites for crack propagation that in the future will degrade the structural integrity of the cylinder. From the visual inspections done in this investigation, including the

Extent of Primary Crack
Three-Point Bend Specimen

Cyl. No. T-256255

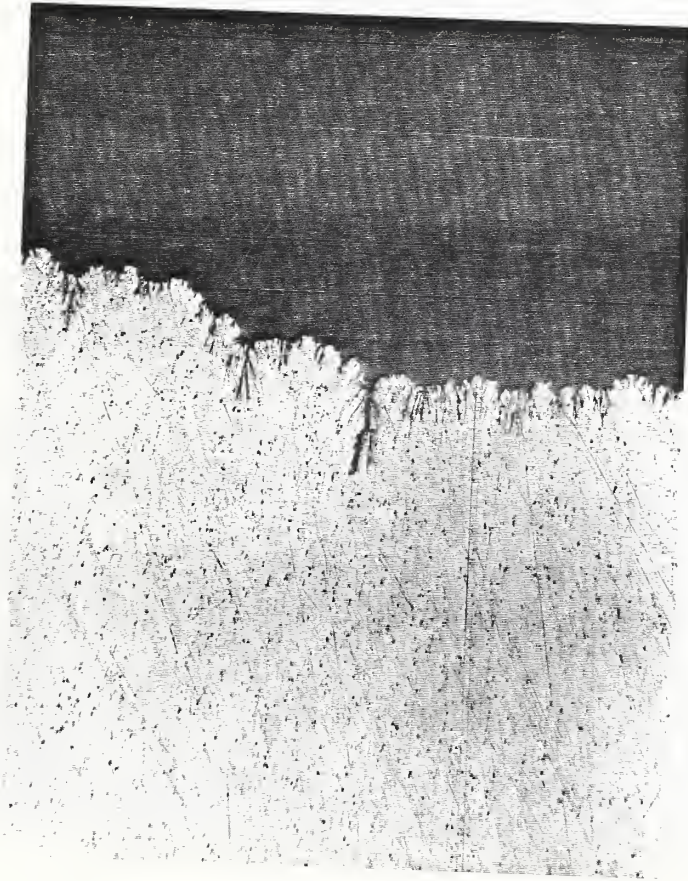
Fig. 21

Metallographic examination of the crack at position "3" was conducted with successive sections taken starting from the lower part of the inside of the neck of the cylinder. As shown in Figure 21, the crack-like indications were identified by metallographic examination to be distinct cracks. Multiple cracks and branching cracks were found that originated at the root of the metal folds in the cylinder neck. The maximum depth of the crack measured on the metallographic specimen (d) at position "3" was approximately 0.020-inch deep and the metallographic examination showed that the cracks were approximately 3/4-inch long but did not extend into the threaded area outside of the neck area of the cylinder. This examination did confirm that the crack-like indications that were observed by visual examination in the neck of the cylinder were definitely cracks and that multiple cracks existed that could not be distinguished by visual observation from the fold in the neck of the cylinder.

Crack at Position '3'

Cyl. No. T-256255 Mag. 40x

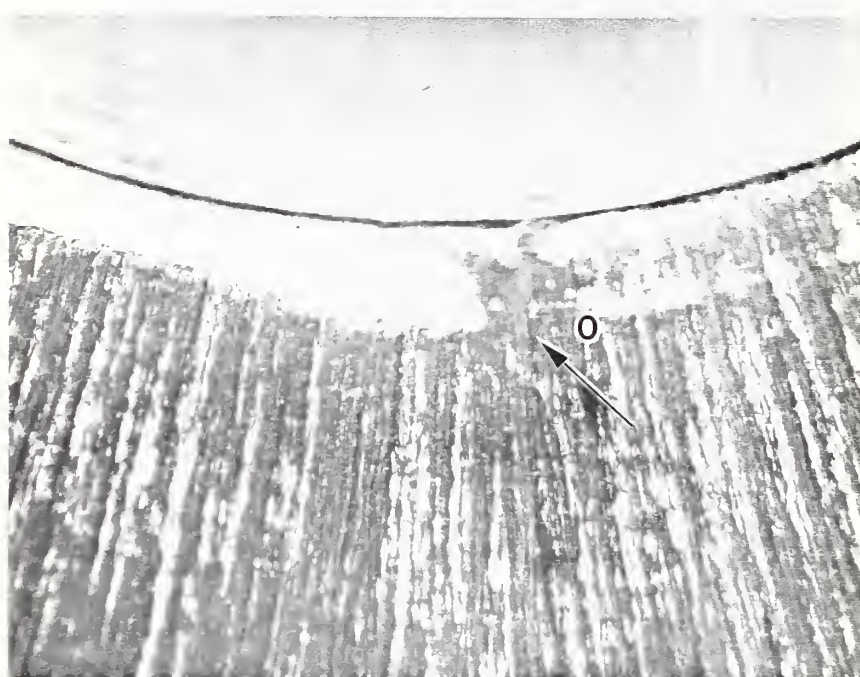
Fig. 22

Visual examination showed the presence of crack-like indications at positions "0", "6" and "10". All the crack-like indications were approximately 1/2-inch long and none extended into the threaded portion of the cylinder head above the neck. An example of the most distinct crack found by visual examination at position "0" is shown in Figure 22. No three point bend specimens were taken from this cylinder.

Crack-Like Indication

Cyl. No. WK-31111 Mag. 12x

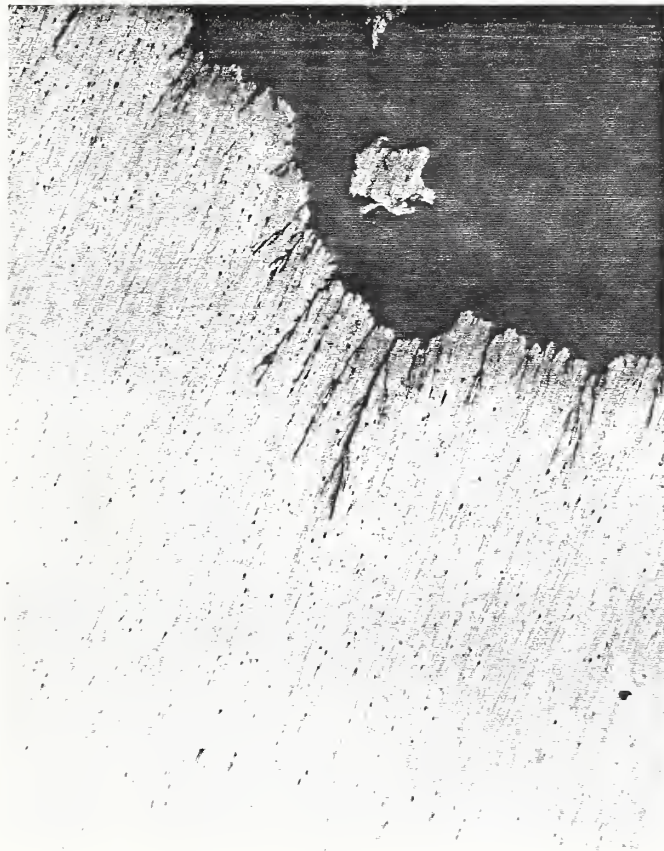
Fig. 23

Metallographic examination of the crack-like indications at position "0" was conducted with successive sections taken starting from the lower part of the inside of the neck of the cylinder. As shown in Figure 23 distinct cracks were found in the wall of the neck region of the cylinder. Multiple cracks and branching cracks were found that originated at the root of the metal folds in the cylinder neck. The maximum depth of the crack at position "0" that was measured on the metallographical specimen was approximately 0.031-inch and the metallographic examination showed that the crack was approximately 1/4-inch long but did not extend into the threaded area outside of the neck area of the cylinder. This examination confirmed the crack-like indications which were observed by visual examination in the neck of the cylinder were definitely cracks and that multiple cracks existed that could not be distinguished by visual observation from the fold in the neck of the cylinder. The maximum thickness

Primary Crack in Cylinder Neck
Cyl. No. WK-31111 Mag. 40x

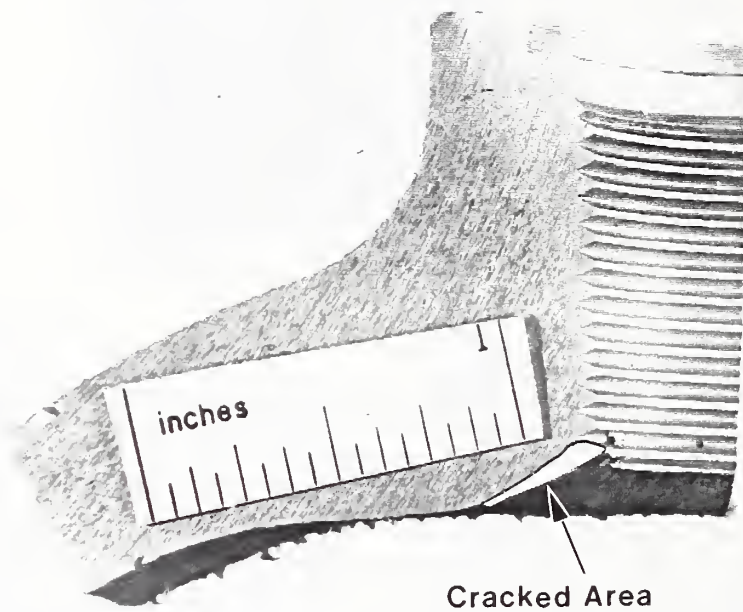
Fig. 24

of the cylinder neck is approximately 3/4-inch, so as shown in Figure 24, the total depth of cracking is limited to less than 5% of the wall thickness of the neck. This amount of crack growth is not considered to be critical or to degrade the structural integrity of the cylinder at this time. Due to the limited extent of cracking at position "0", the other crack-like indications at positions "6" and "10" were not examined metallographically at this time.

Extent of Primary Crack

Cyl. No. WK-31111

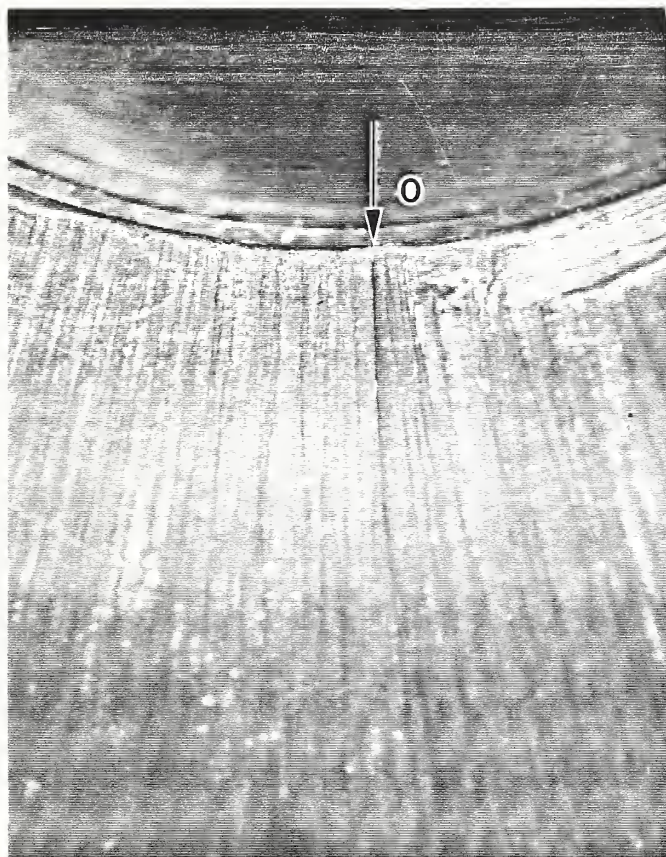
Fig. 25

Visual examination conducted as part of this investigation showed the presence of crack-like indications at positions "0" and "2". Both crack-like indications were approximately 1/2-inch long. Neither of the crack-like indications extended into the threaded portion of the cylinder head above the neck. An example of the most distinct crack found by visual examination at position "0" is shown in Figure 25. A three point bend specimen was cut from the cylinder at position "0" and tested in an attempt to delineate the crack at this position. This specimen did not fracture at the correct position to determine the crack size in this manner. However, the size of the crack at this position could still be determined by metallographic examination.

Crack-Like Indication

Cyl. No. WK-32699 Mag. 10x

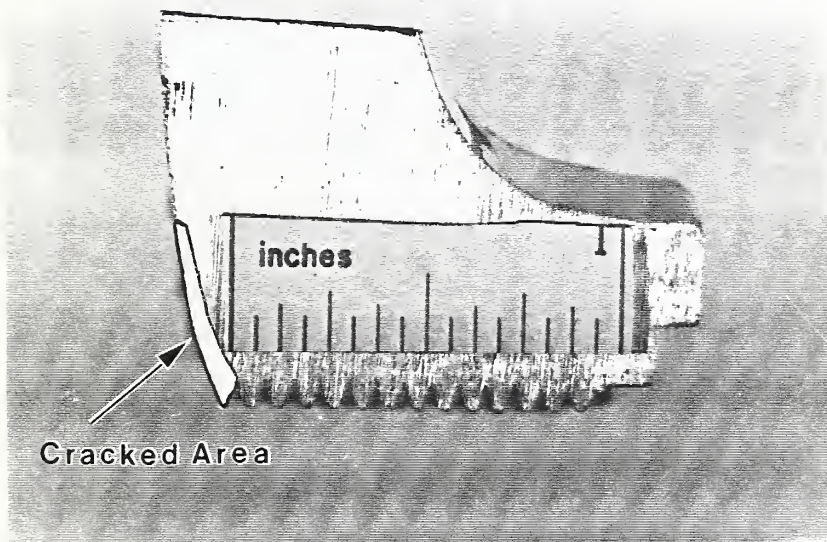
Fig. 27

Extent of Primary Crack

Cyl. No. WK-32699

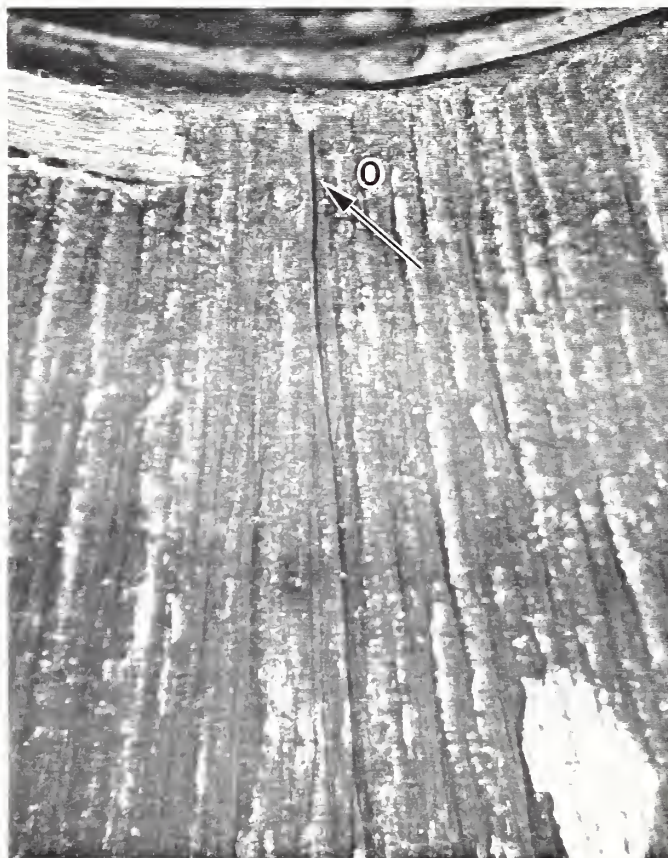
Fig. 28

The detailed visual examination conducted as part of this investigation showed the presence of crack-like indications at positions "0," "1","2","3","5","6" "8", "9", "10", and "11. The crack-like indications were approximately 1/2-inch long and that none extended into the threaded area of the cylinder head above the neck. An example of the most distinct crack-like indication found by visual examination at position "0" is shown in Figure 28. A three point bend specimen was cut from the cylinder at position "0" and tested in an attempt to delineate the crack at this position. This specimen did not fracture at the correct position to determine the crack size in this manner. However, the size of the crack at this position could still be determined by metallographic examination.

Crack-Like Indication

Cyl. No. WK-31631 Mag. 12x

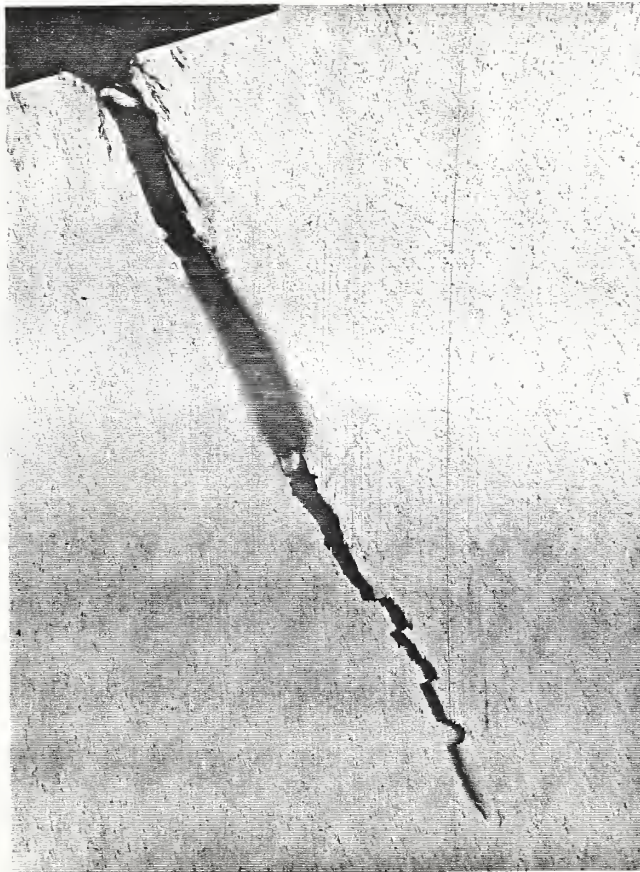
Fig. 29

Metallographic examination of the crack-like indication at position "0" was conducted with successive sections taken starting from the lower part of the inside of the neck of the cylinder. As shown in Figure 29, distinct cracks were found in the wall of the neck region of the cylinder. Multiple cracks and branching cracks were found that originated at the root of the metal folds in the cylinder neck. The depth of the largest crack measured on the metallographic specimen (d) at position "0" was approximately 0.236-inch and the metallographic examination showed that the crack was approximately 5/8-inch long but did not extend into the threaded area outside of the neck area of the cylinder. This is a substantial crack and indicates that substantial crack propagation has occurred during the three years that the cylinder was in service. The maximum thickness of the cylinder neck is approximately 3/4-inch, so as shown in Figure 30, the total depth of cracking was approximately 15% of the thickness of the neck. This crack clearly shows the extent of cracking that can occur in these hoop wrapped cylinders and shows that even a crack of this depth does not extend into the threaded area of the neck and would not be detected by only looking at the threads of the cylinder. An analysis of the structural significance of this crack was not made at this time but it is expected that a crack of this depth would be expected to grow to the extent that leakage of the cylinder would occur before the next required hydrostatic test. This examination did confirm that the crack-like indications observed by visual examination in the neck of the cylinder were definitely cracks and that multiple cracks existed that could not be distinguished by visual observation from the fold in the neck of the cylinder. The other crack-like indications at positions "1" through "11", were not examined metallographically at this time.

Primary Crack in Cylinder Neck
Cyl. No. WK-31631 Mag. 18x

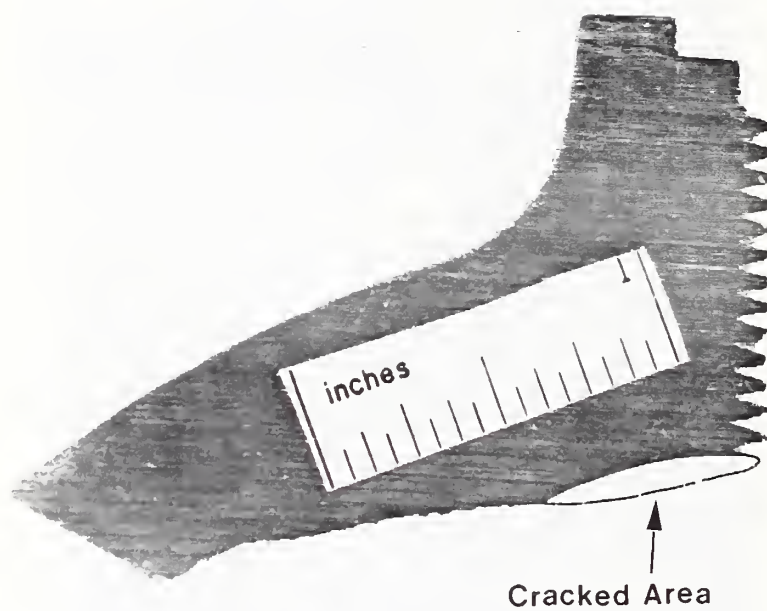
Fig. 30

Extent of Primary Crack

Cyl. No. WK-31631
